Working Historic Machinery: Policy and Procedures

Appendix A - Example Condition Report (Walker Ventilation Fan)

Working Machinery Assessment BP002

Walker Ventilation Fan

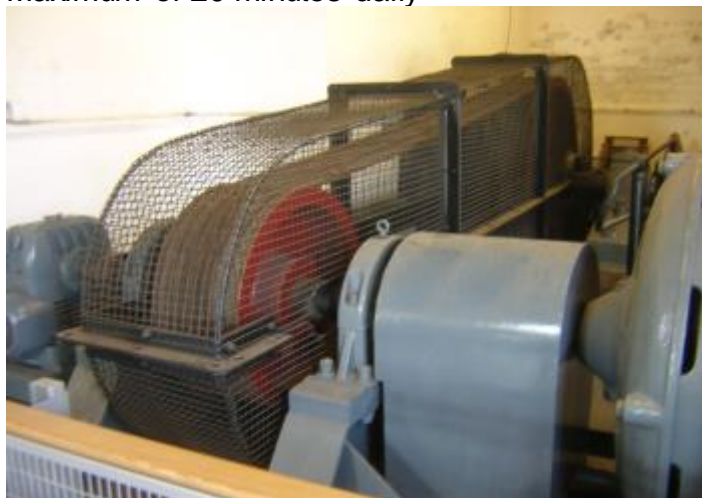
CONDITION SURVEY

Description / History

This machine replaced an earlier mine ventilating fan in 1910, it was electrically driven with power to the impeller being transmitted originally by 2 pulleys and a wide flat drive belt. This belt and both flat pulleys were later replaced by 6 narrower link belts and grooved pulleys.

The impeller is 10' in diameter; it has 10 vanes and has a double air inlet. It rotated at 261 revolutions per minute. This Walker fan stopped working in 1975 when a more efficient machine was installed.

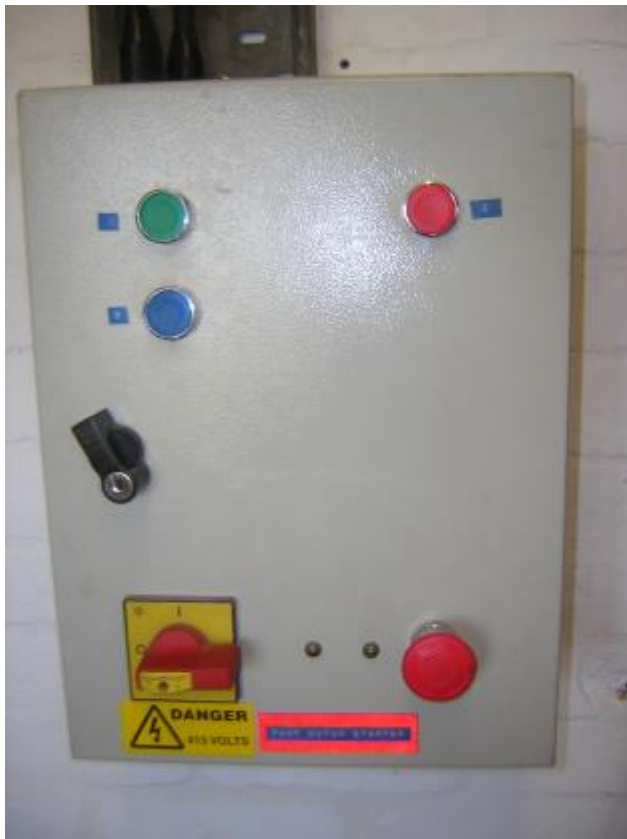
1a) Operators checks daily or before use

- a) Drive unit Guards are secure and undamaged
- b) Pulley Guards are secure and undamaged
- c) Pulleys (P1+P2) for security / damage
- d) Timber planking above impeller are secure
- e) Impeller Vanes for damage and Security
- f) Ensure Emergency Stop button is in the out position

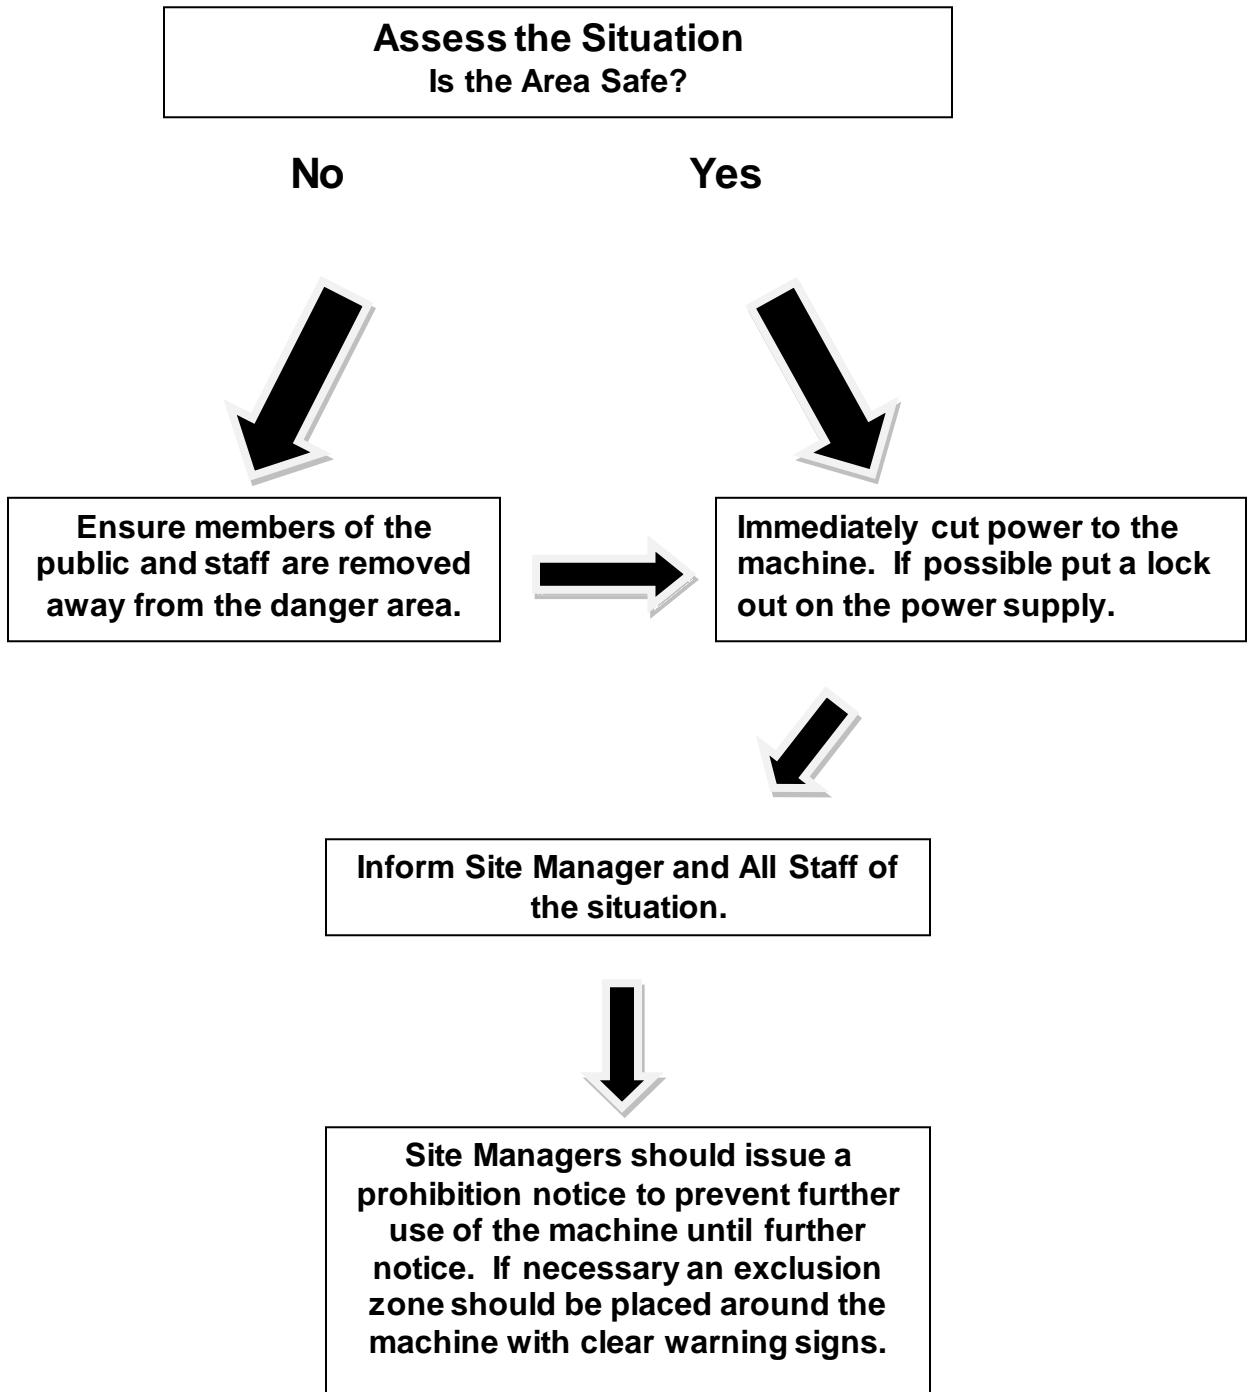
Working Historic Machinery Emergency Procedure

In the event of a serious mechanical failure follow the procedure below.

In the event of a sudden mechanical failure the following procedure should be followed:

1. Quickly assess the situation. Ensure that no one, either yourself; staff or public are in any danger.
2. Shut off the power and if possible lock it out.
3. Inform site manager and all staff of the situation.
4. Site managers should prohibit the use of the machine until further notice.
